**HALL CONTRACTING PTY LTD
LEVEL ONE EARTHWORKS COMPLIANCE REPORT
FOR EARTHWORKS FILLING OPERATIONS
FRASER ROAD AND LOTS 9 TO 16
STAGE 23 NORTH HARBOUR BURPENGARY**

Maroochydore Office
Job: ML17/090 (DL17-006)
Ref: 2445 Rev0
Author: D Taylor

**RE: LEVEL ONE EARTHWORKS COMPLIANCE REPORT FOR
EARTHWORKS FILLING OPERATIONS –
FRASERS ROAD AND LOTS 9 TO 16
STAGE 23 NORTH HARBOUR BURPENGARY**

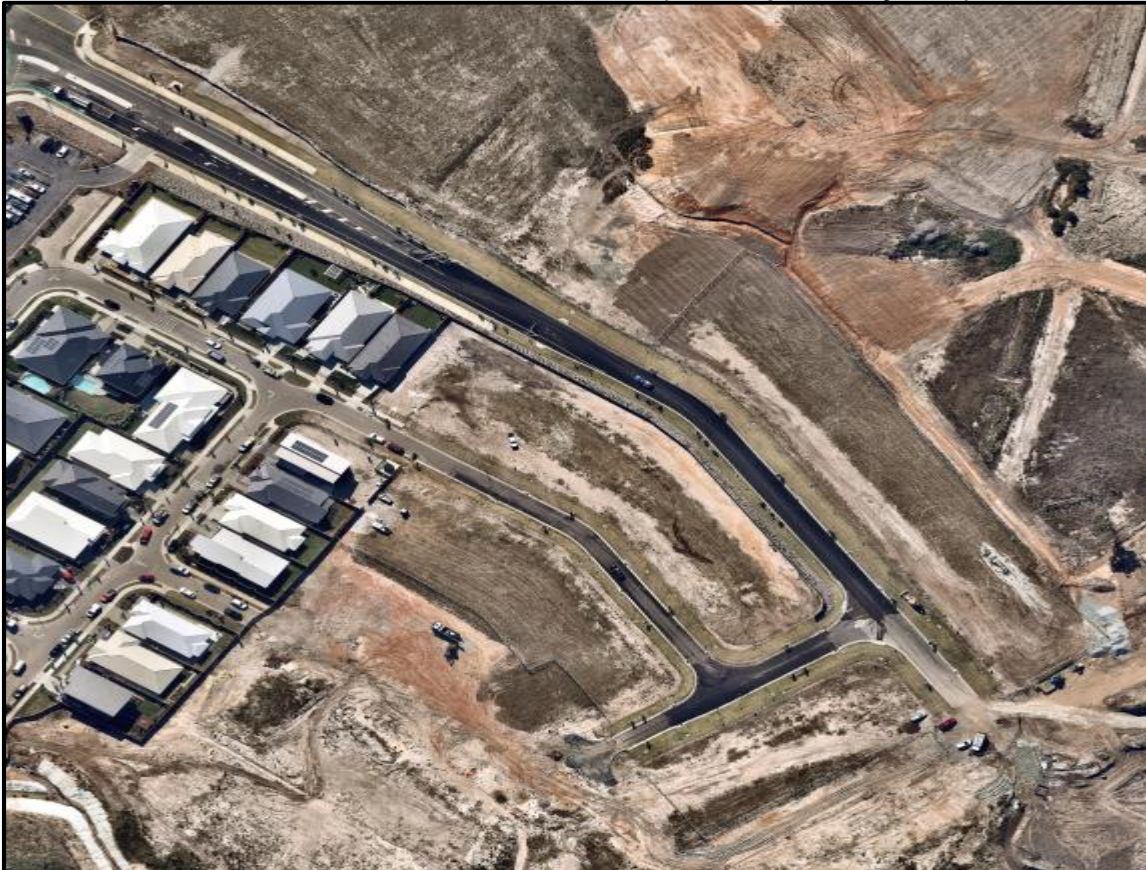
Photo 1 – Aerial View View of the Site (Nearmap 26th July 2018)

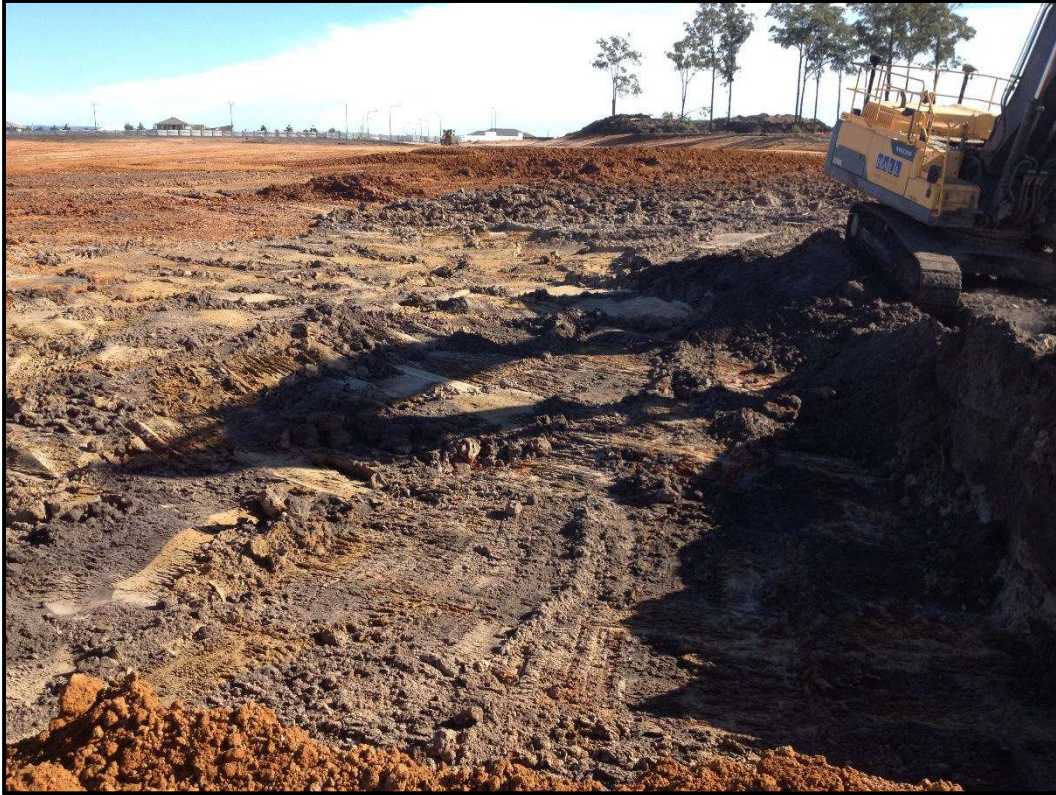
The stripped surface was proof rolled using loaded water truck carrying out multiple passes. When no discernable movement or vertical deflection was observed, the stripped surface was assessed to be suitable for support and placement of new fill.

Photo 2 – View of Stripped Surface Prior to Placement of Fill

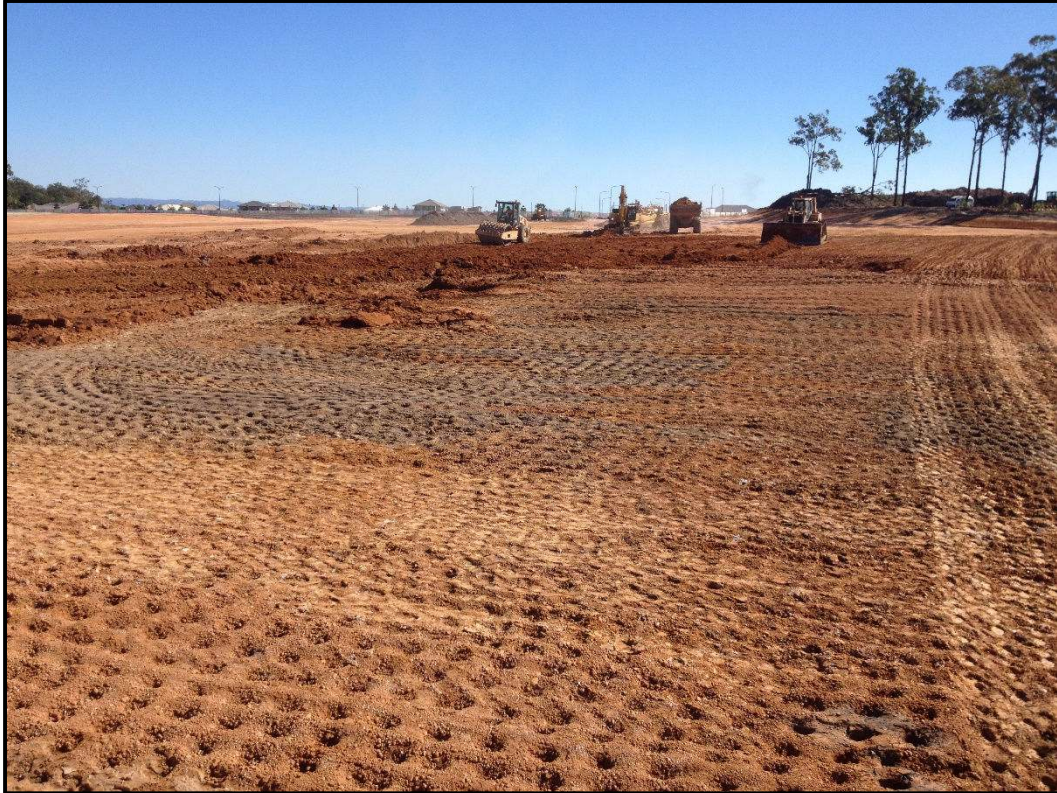
Photo 3 – View of Filling Operations

All fill was placed in thin layers appropriate for the above plant and compacted by carrying out several passes (up and back). The fill was moisture conditioned at the fill source and during placement and thoroughly mixed to achieve moisture contents suitable for compaction. Materials containing excessive amounts of silts or deleterious materials such as sticks, or construction debris were sorted to remove contaminants prior to placement, or rejected for use.

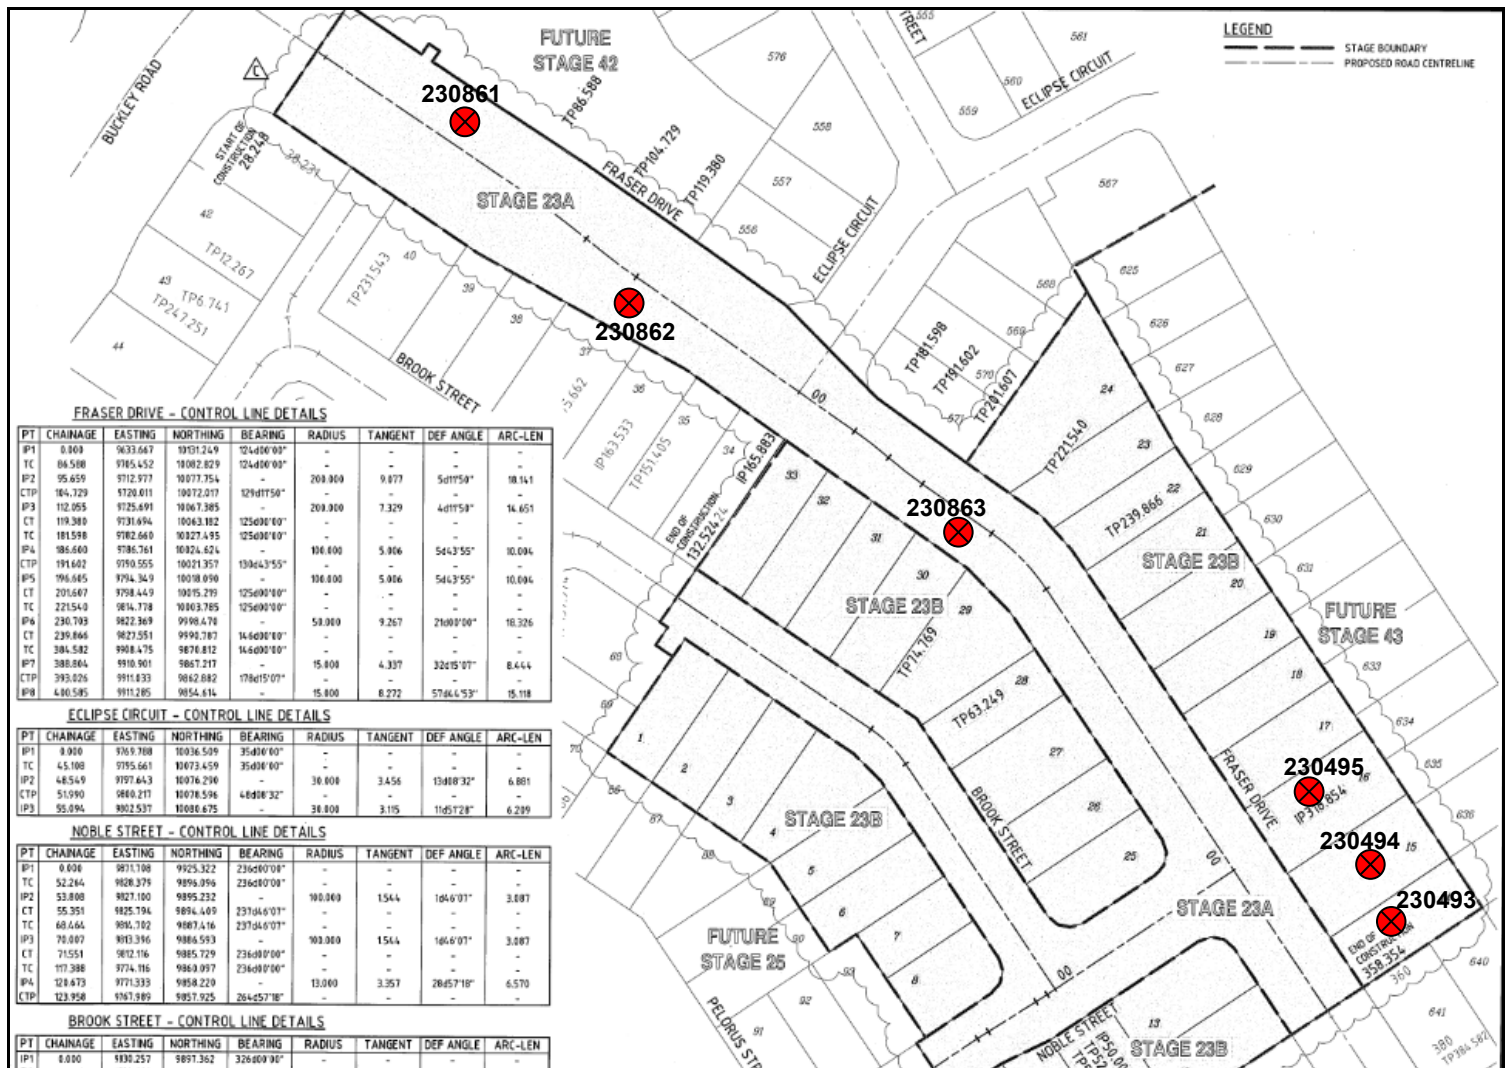
Test Location Plan

Test Locations are attached as Appendix B. Test locations and levels were not obtained by survey and therefore should only be considered as approximate.
