LAND BASED ENVIRONMENTAL MANAGEMENT PLAN - SUB-PLAN 03

North East Business Park
Residential West Area - Phase 2

A Report Prepared for
North East Business Park Pty Ltd

AS AMENDED
JULY 2015

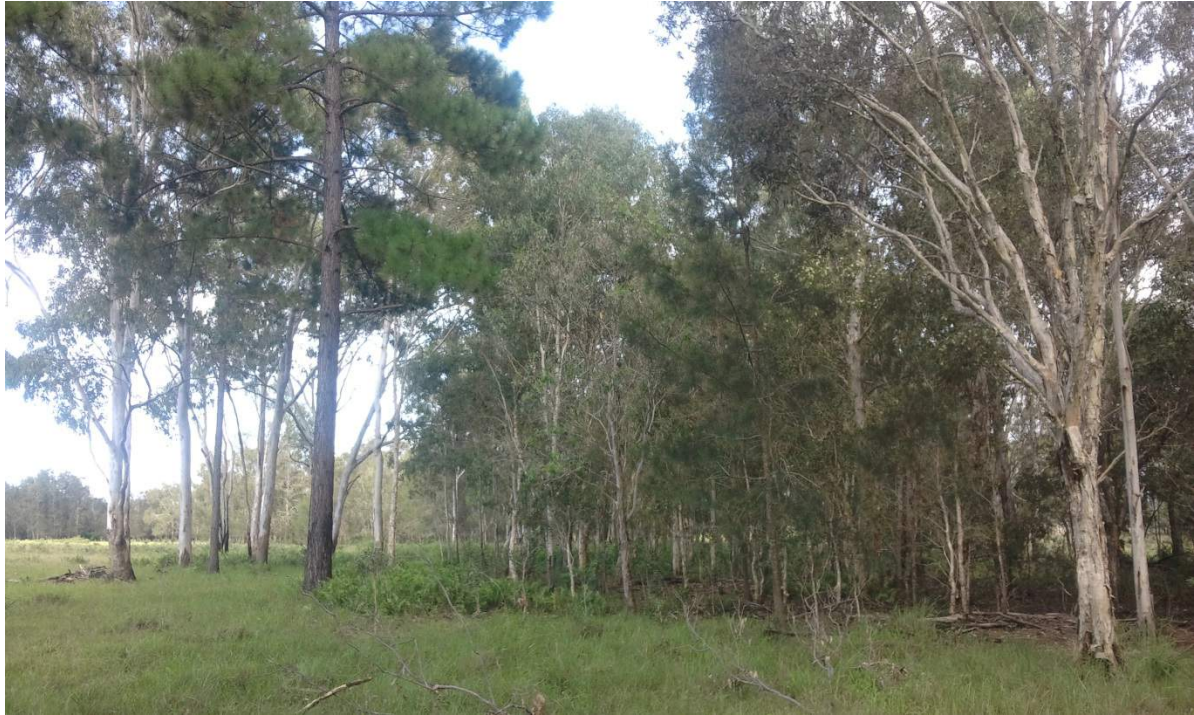
ASSESSMENT SITE 1

Assessment site	1		
Vegetation Assessment level	Quaternary		
Survey point (zone 56)	E499022.842, N7000758.538		
Aspect	flat		
Slope (%)	0		
Geology	flood plain		
Soil type	Earth/Organic, clayey earth		
Soil colour	dark brown		
Declared Weeds	broad leaved pepper tree, lantana,		
Erosion	nil		
Grazing impacts	Occasional,		
Fire history	> 10 year		
Hydrology indicators	Flood debris, flood staining,		
Fauna habitat	channel appears artificial cut		
General notes	Possible salt water influence, channel only		
Strata	Dominant Species	Height	FPC%
Canopy T1	Eucalyptus tereticornis	16	15
T2	Casuarina glauca, Melaleuca quinquenervia, Acacia concurrans	10	35

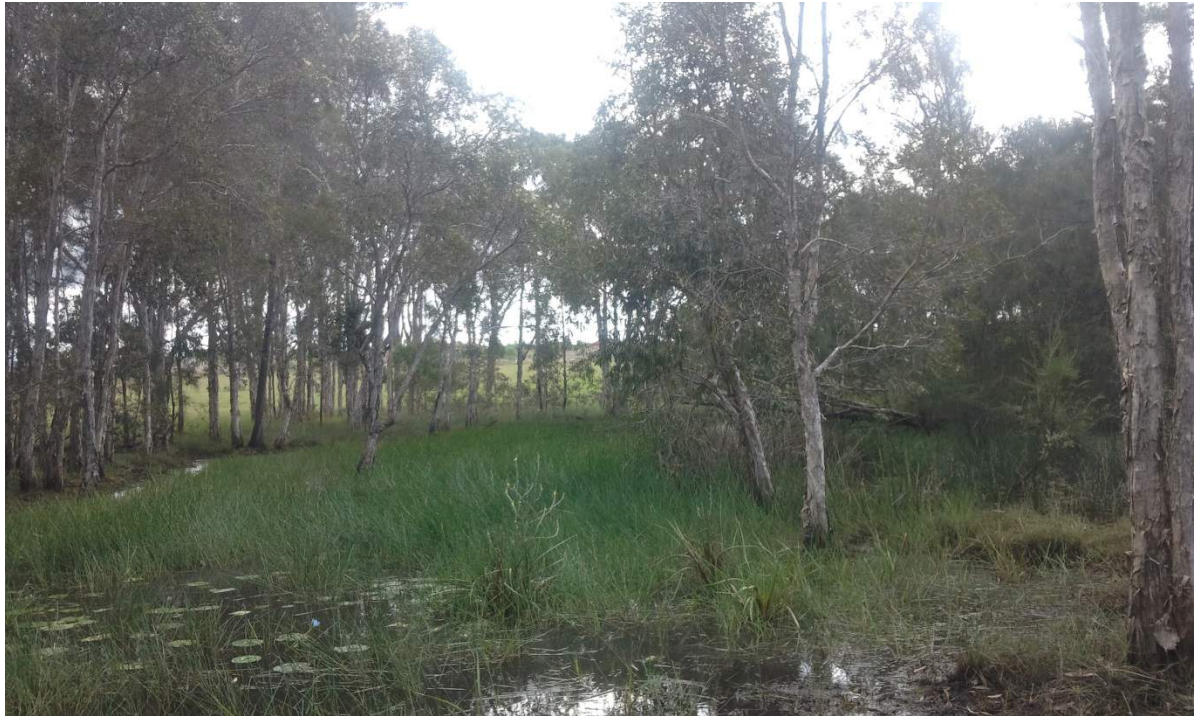
ASSESSMENT SITE 2

Assessment site	2
Vegetation Assessment level	Veg confirmation
Survey point (zone 56)	E498675.069, N7000821.903
Hydrology indicators	Inundated areas
Fauna habitat	Koala scats
General notes	-
Vegetation	Paperbark forest, Melaleuca quinquenervia, Eucalyptus tereticornis
Level of disturbance	Not significant

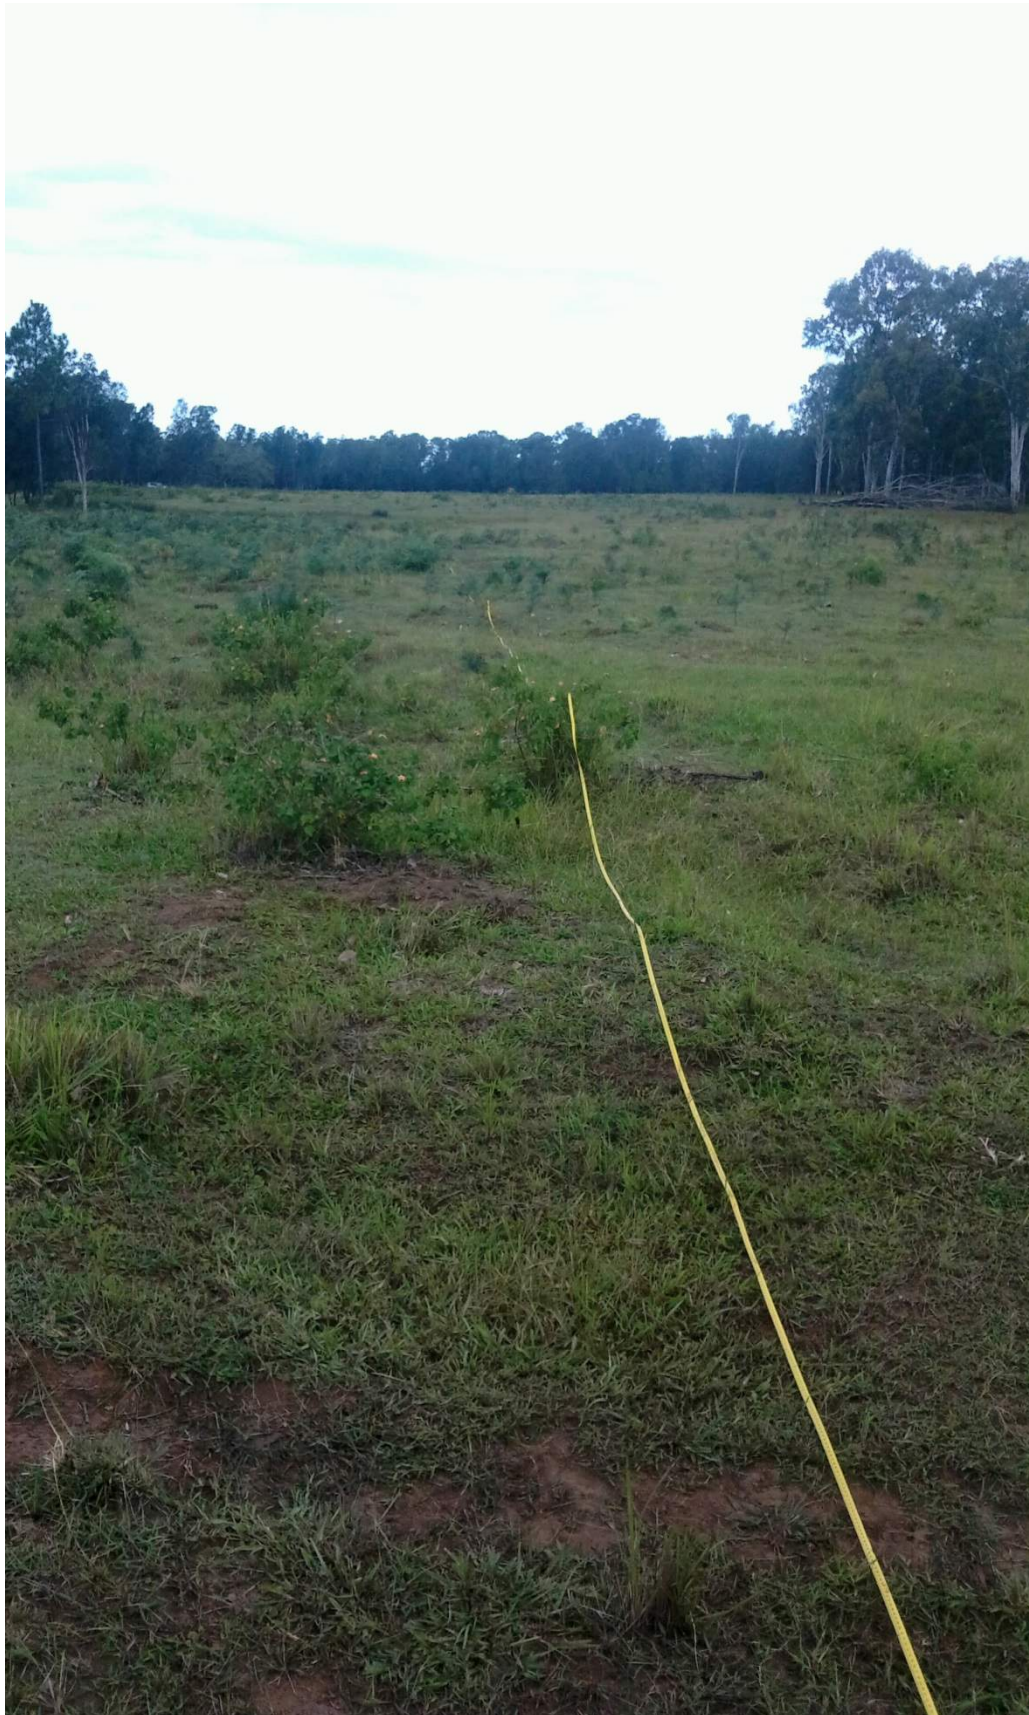
ASSESSMENT SITE 3

Assessment site	3		
Vegetation Assessment level	Tertiary		
Survey point start (zone 56)	E498897 N7000932		
Survey point finish	E498940 N7000909		
Baring of transect	w-e		
Aspect	flat top small rise		
Slope (%)	0		
Geology	small rise		
Soil type	Clay-red cracking clay		
Soil colour	red		
Declared Weeds	lantana		
Erosion	Tunnel, Minor, holes		
Grazing impacts	Moderate, trampling		
Fire history	> 10 year		
Hydrology indicators	No hydrology indicators		
Fauna habitat	-		
General notes	Not a wetland		
Strata	Dominant Species	Height	FPC%
Canopy T1	0	0	0
T2	0	0	0
Shrubs	Pteridium esculentum, Gomphocarpus physocarpus, Breynia oblongifolia, Lophostemon sauveolens	1	30
Ground cover	Imperata cylindrica, Poaceae sp. , Cynodon dactylon, Paspalum sp., Sporobolus sp.	0.2	Veg 96% Litter 1% Bare 3%
Basal Count Species	Count		
0	0		
Level of disturbance	Significant

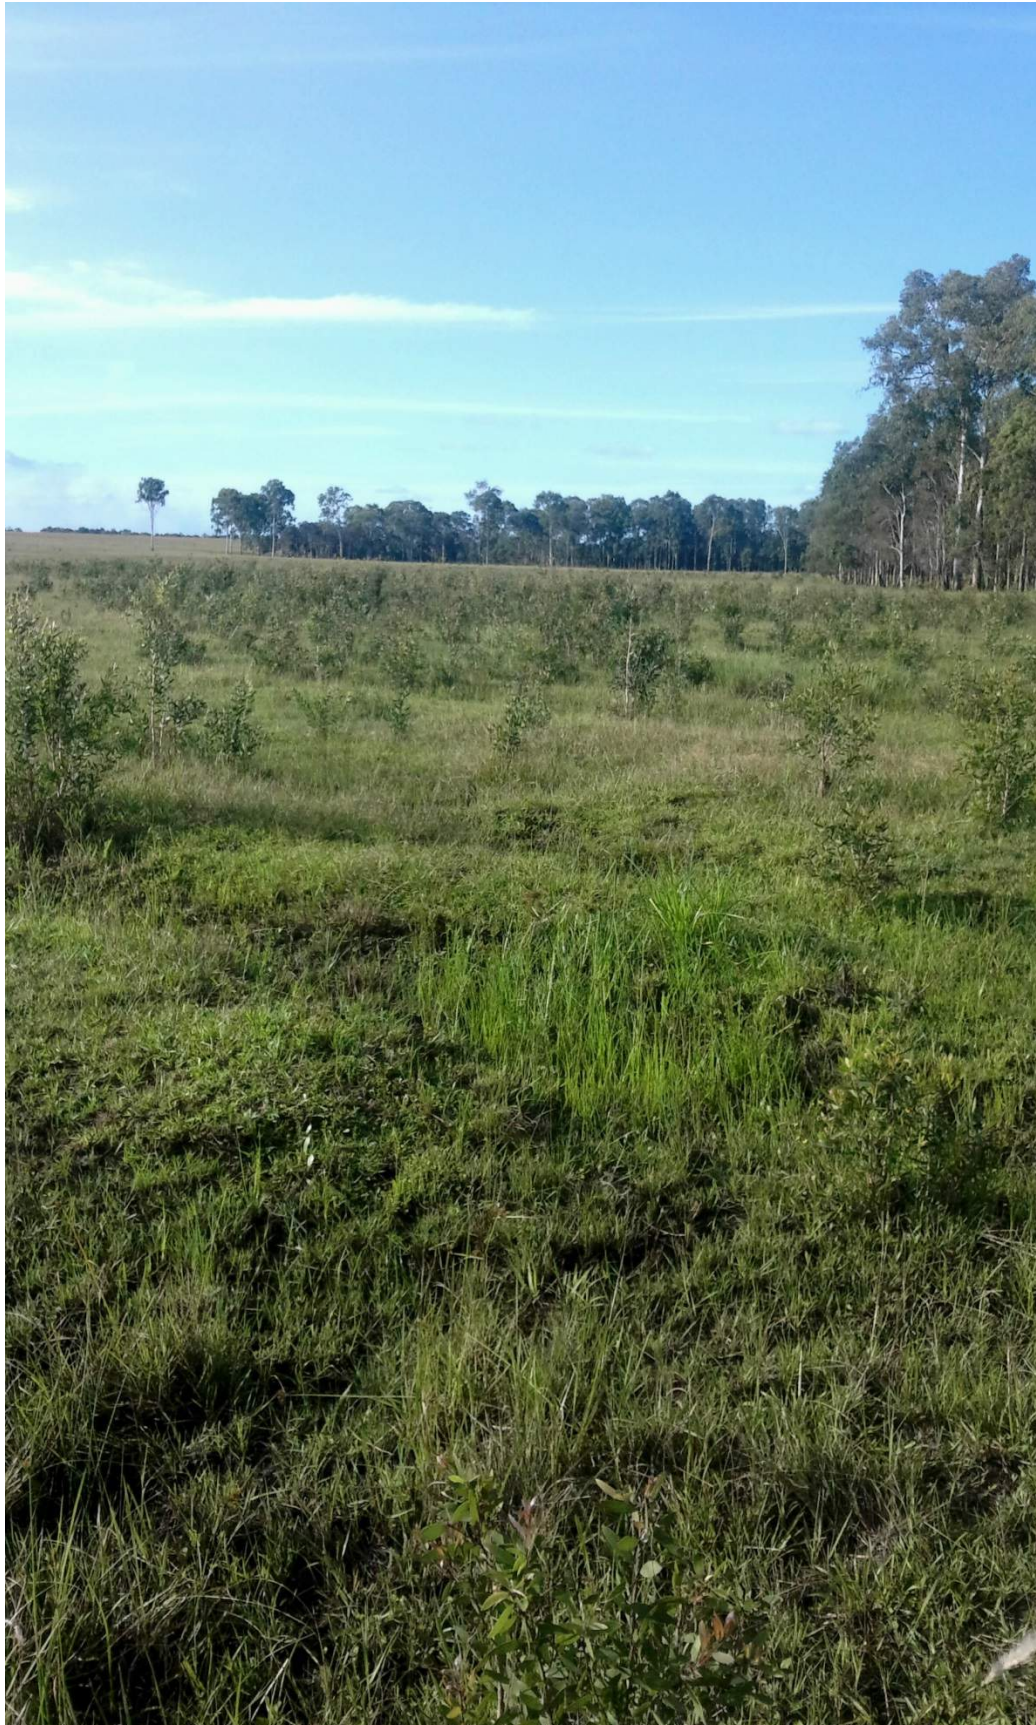
ASSESSMENT SITE 4

Assessment site	4		
Vegetation Assessment level	Quaternary		
Survey point (zone 56)	E498464.138, N7000277.361		
Aspect	east		
Slope (%)	2		
Geology	marine sediments		
Soil type	Clay, sandy clay		
Soil colour	grey		
Declared Weeds	0		
Erosion	nil		
Grazing impacts	Moderate,		
Fire history	> 10 year		
Hydrology indicators	Melon holes		
Fauna habitat	melon holes		
General notes	-		
Strata	Dominant Species	Height	FPC%
Canopy T1	0	0	0
T2	0	0	0
Shrubs	Melaleuca quinquenervia, Gomphocarpus physocarpus, Leptospermum sp.	1	30
Ground cover	Cyperus polystachyos, Poaceae spp., Imperata cylindrica	0.3	0
Level of disturbance	Significant

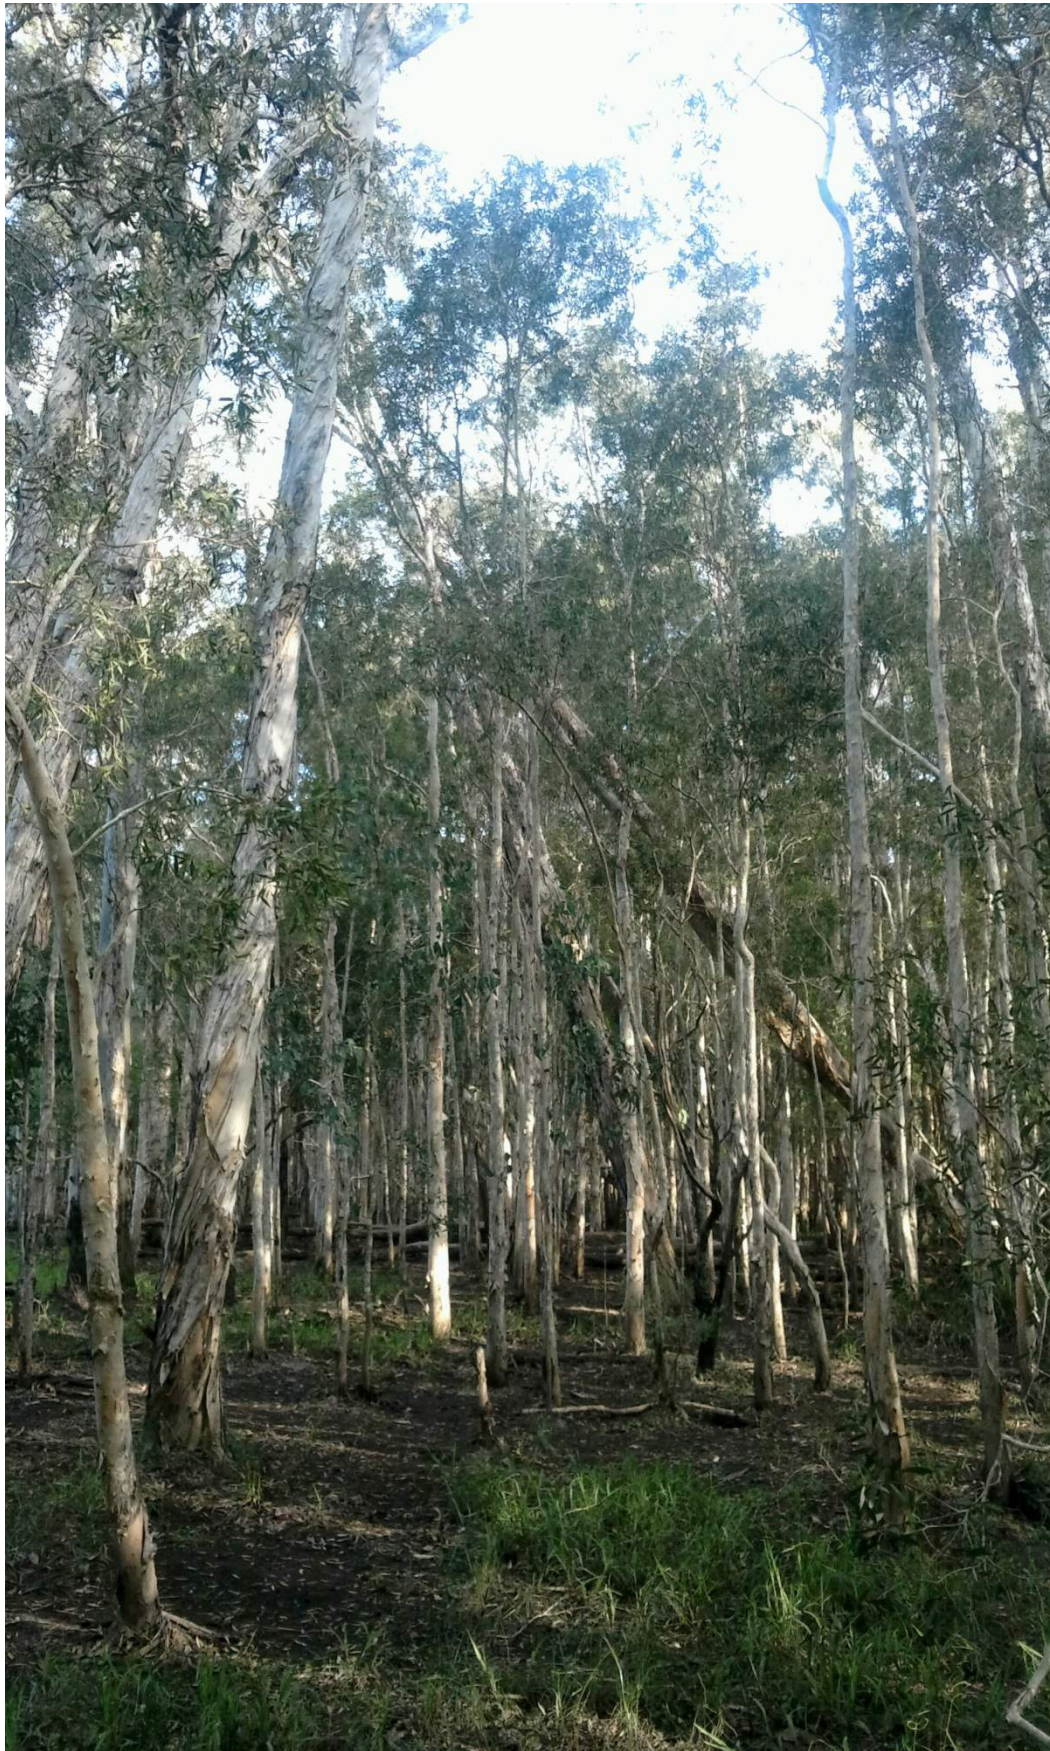
ASSESSMENT SITE 5

Assessment site	5		
Vegetation Assessment level	Tertiary		
Survey point start (zone 56)	E498529 N7000282		
Survey point finish	E498533 N7000237		
Baring of transect	n-s		
Aspect	flat		
Slope (%)	0		
Geology	wetland/watercourse		
Soil type	Earth/Organic-silty earth		
Soil colour	brown		
Declared Weeds	0		
Erosion	Sheet, Minor, flood		
Grazing impacts	Occasional,		
Fire history	> 10 year		
Hydrology indicators	Inundated areas, swamp hummocks, flood carried debris, flood staining		
Fauna habitat	watercourse, standing water		
General notes	vc2, vc5,		
Strata	Dominant Species	Height	FPC%
Canopy T1	Melaleuca quinquenervia, Eucalyptus tereticornis	15	84
T2	Melaleuca quinquenervia, Lophostemon sauveolens, Eucalyptus tereticornis, Melaleuca linariifolia,	8	40
Shrubs	Acacia sp., Melaleuca quinquenervia,	3	5
Ground cover	Centella asiatica, Sida rhombifolia, paspalum sp., Gahnia sieberiana, Tradescantia fluminensis	0.3	Veg 27% Litter 47% Bare 31.4%

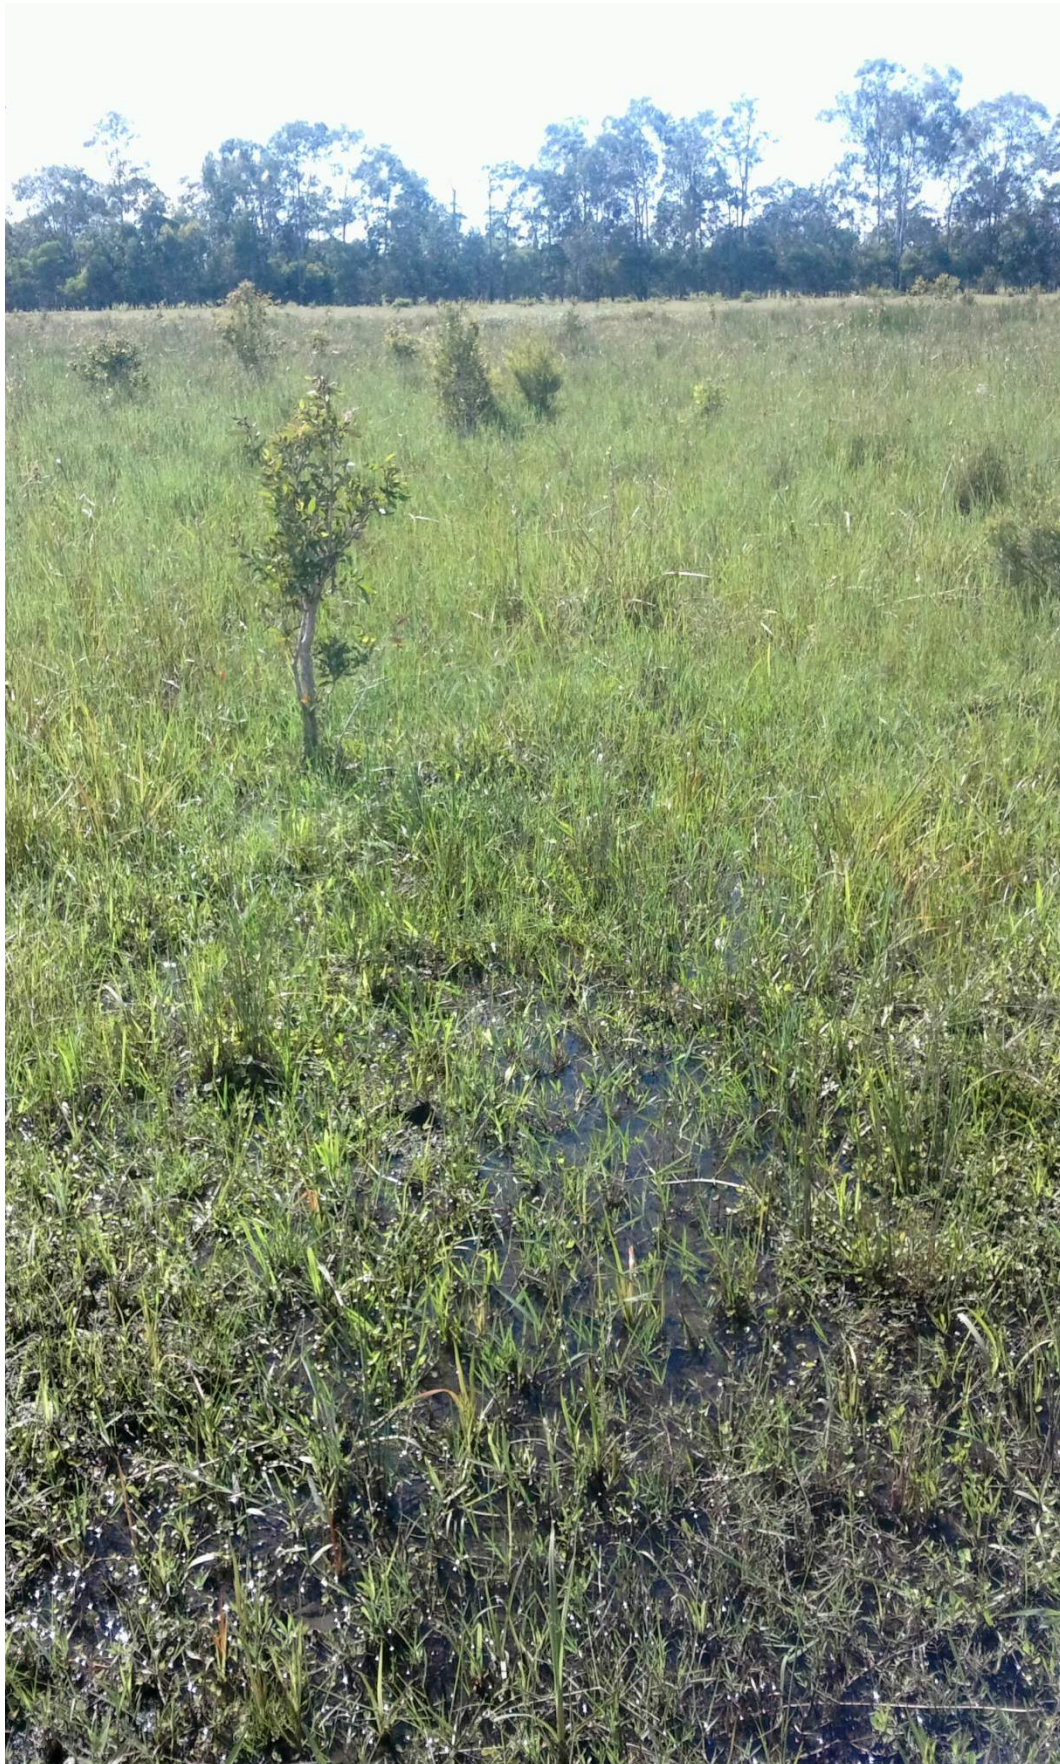
ASSESSMENT SITE 6

Assessment site	6		
Vegetation Assessment level	Quaternary		
Survey point (zone 56)	E498567.827, N7000485.871		
Aspect	flat		
Slope (%)	0		
Geology	wetland, standing water		
Soil type	Earth/Organic, clayey earth		
Soil colour	dark brown		
Declared Weeds	0		
Erosion	nil		
Grazing impacts	Occasional, trampling, grazing		
Fire history	> 10 year		
Hydrology indicators	Inundated areas, melon holes		
Fauna habitat	standing water, melon holes		
General notes	-		
Strata	Dominant Species	Height	FPC%
Canopy T1	0	0	0
T2	0	0	0
Shrubs	Melaleuca quinquenervia, Melaleuca linariifolia, Melaleuca thymifolia	2	20
Ground cover	Cyperus haspan, Fimbristylis ferruginea, Fimbristylis autumnalis, Fimbristylis miliacea, Fuirena sp., Juncus spp., Fimbristylis miliacea	0.5	95
Level of disturbance	Significant

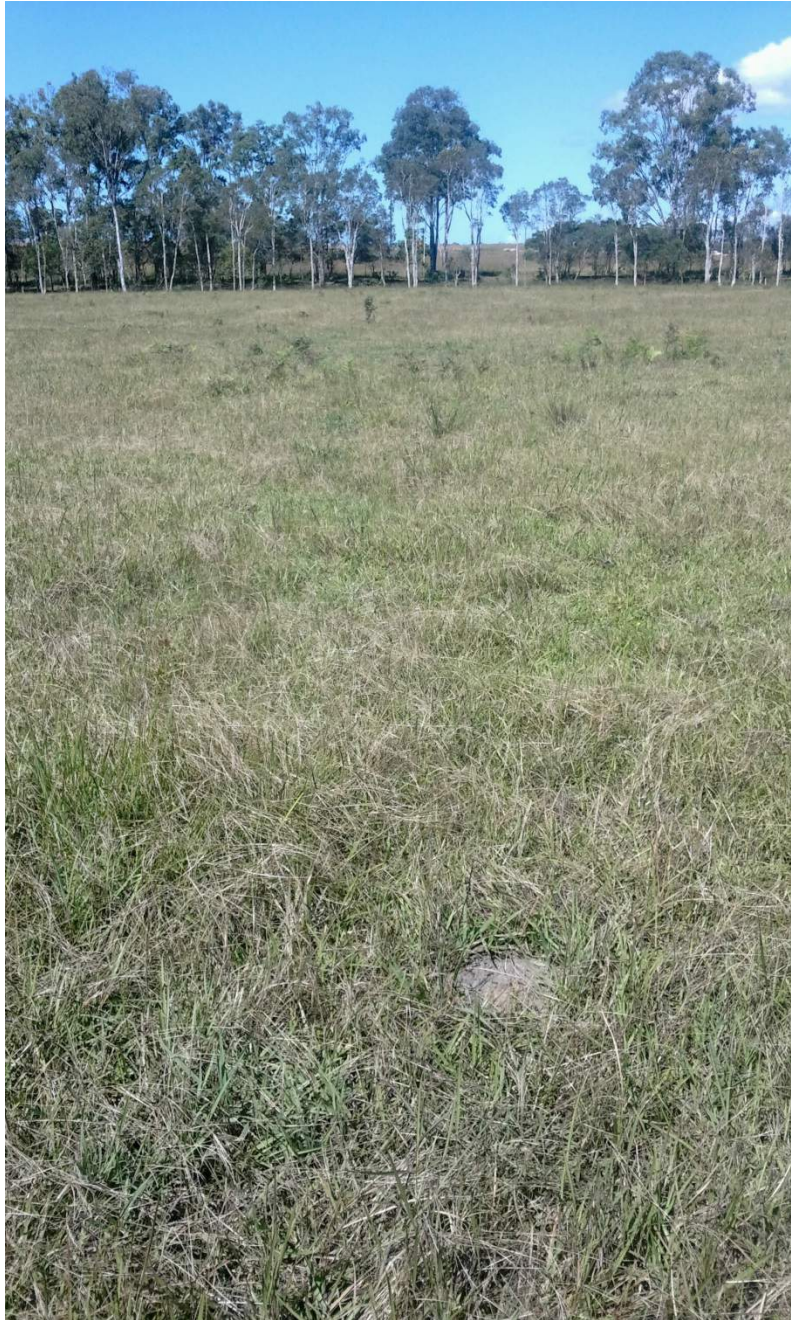
ASSESSMENT SITE 7

Assessment site	7
Vegetation Assessment level	Veg confirmation
Survey point (zone 56)	E499314.144, N7000608.403
Hydrology indicators	melon holes <50%
Fauna habitat	0
General notes	Not a wetland
Vegetation	Grassland with occasional sedge patches
Level of disturbance	Significant

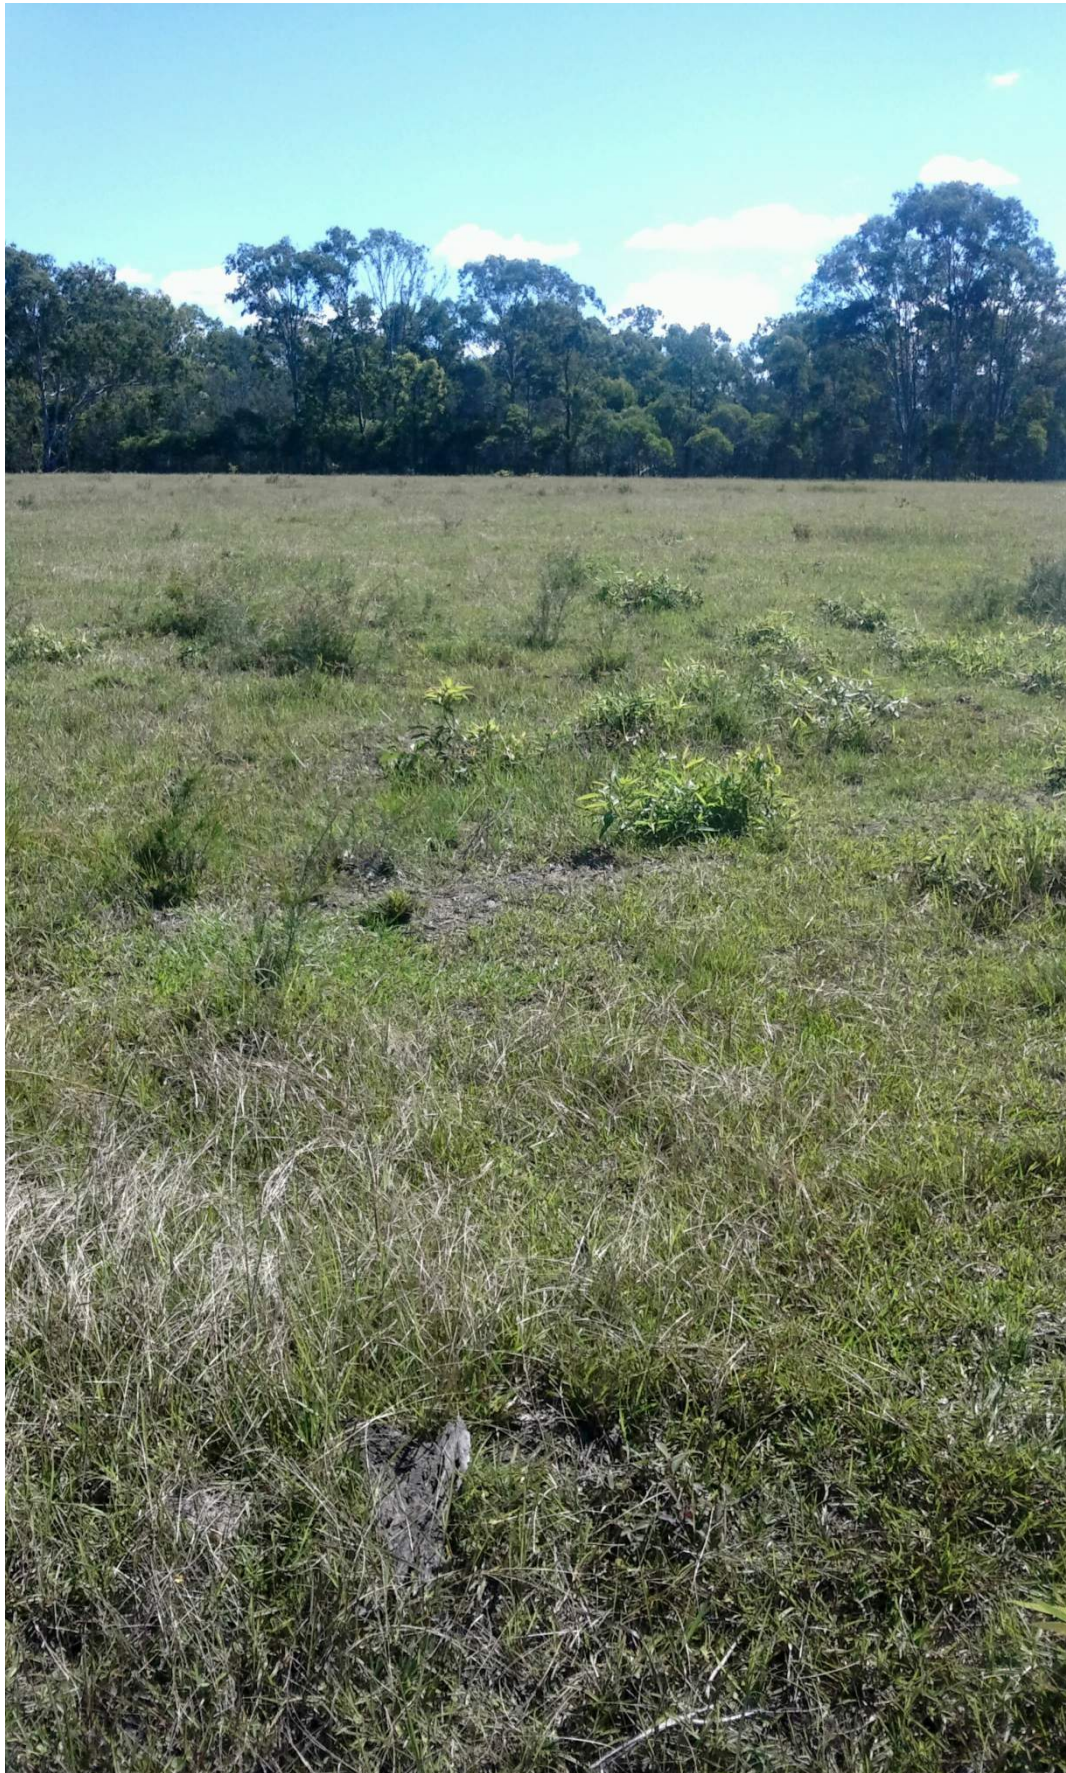
ASSESSMENT SITE 8

Assessment site	8		
Vegetation Assessment level	Quaternary		
Survey point (zone 56)	E498909.92, N7000617.686		
Aspect	flat		
Slope (%)	0		
Geology	flood plain		
Soil type	Clay, med clay		
Soil colour	dark brown		
Declared Weeds	0		
Erosion	nil		
Grazing impacts	Moderate, trampling		
Fire history	> 10 year		
Hydrology indicators	melon holes <50%		
Fauna habitat	swales, no standing water		
General notes	Not a wetland		
Strata	Dominant Species	Height	FPC%
Canopy T1	0	0	0
T2	0	0	0
Shrubs	Melaleuca quinquenervia, Lantana camara, Eucalyptus sp., Acacia sp., Leptospermum sp.	1	2
Ground cover	Cyperus polystachyos, Sporobolus sp., paspalum sp., convolvulus sp., Cynodon dactylon, Imperata cylindrica	0.2	90
Level of disturbance	Significant

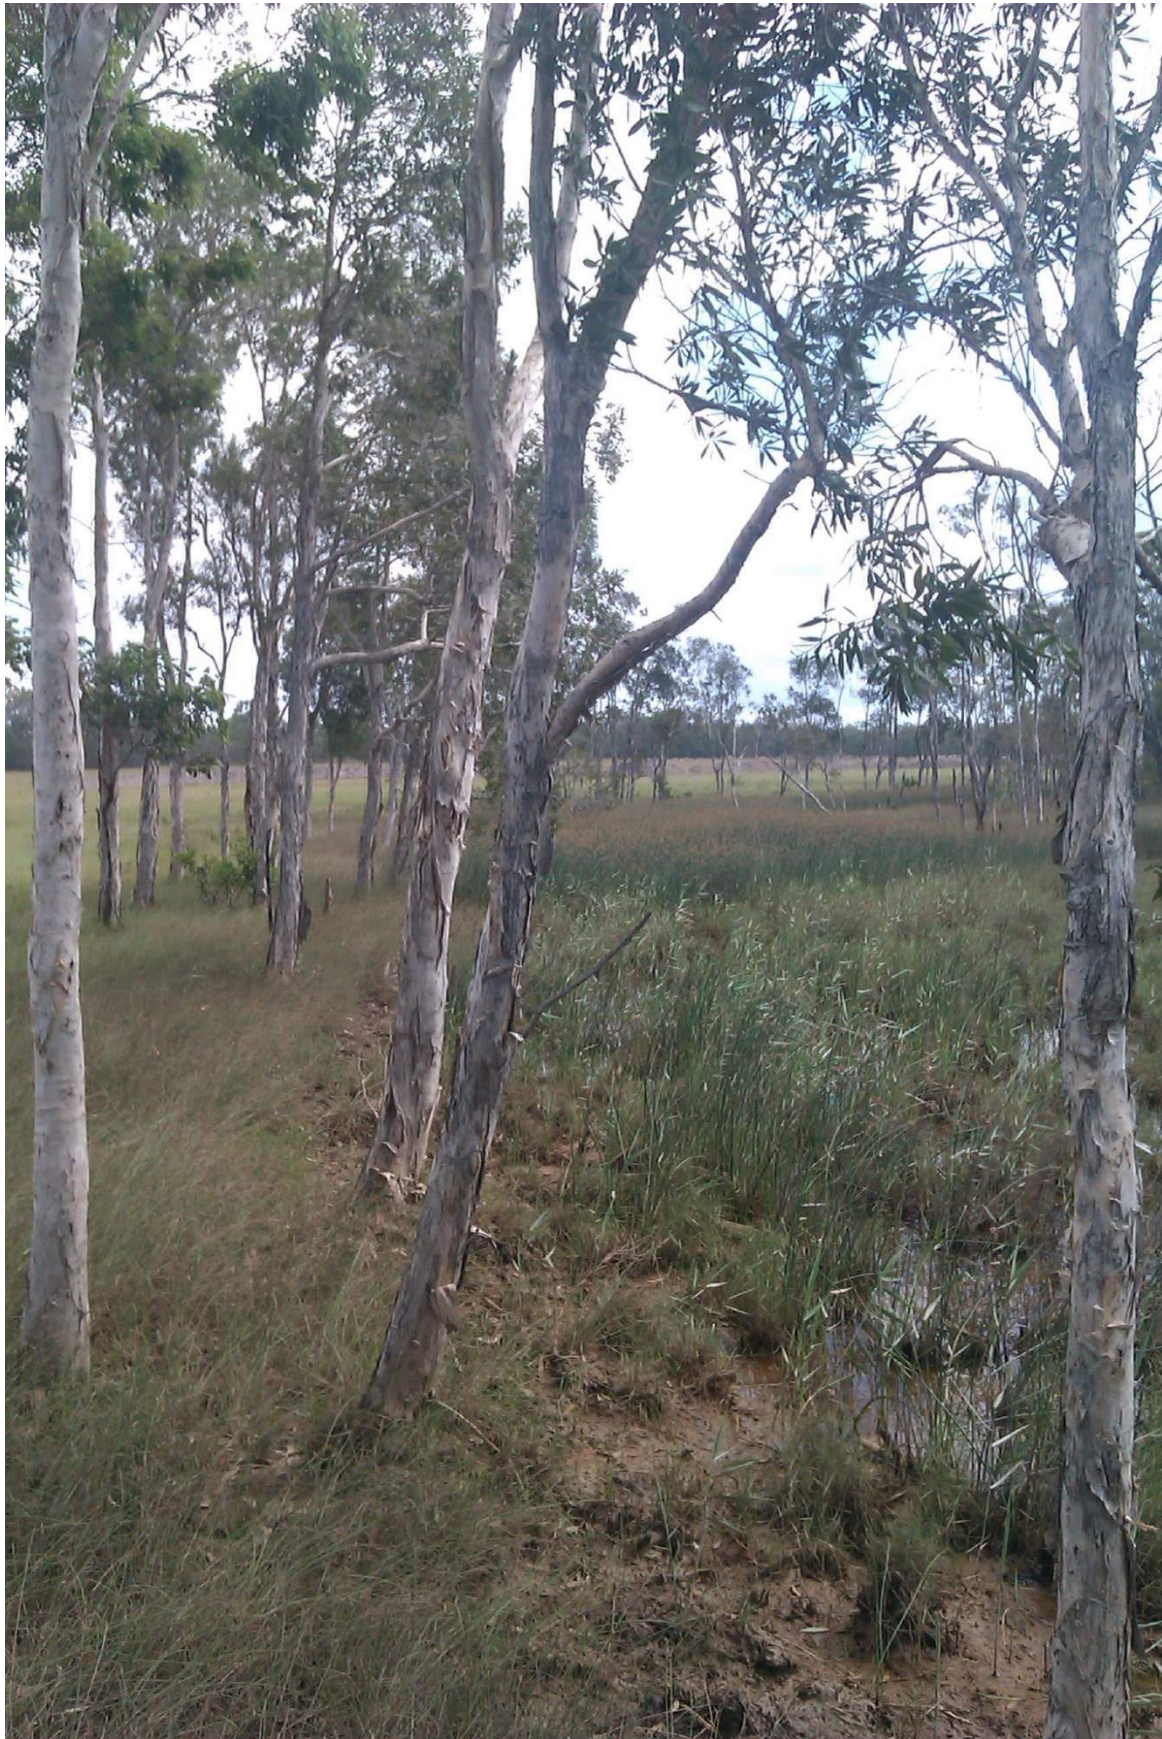
ASSESSMENT SITE 9

Assessment Site	9
Assessment Level	Quaternary
Survey Point	56J 499277 7000451
Aspect	flat
Slope (%)	flat
Geology	Creek bank
Soil	Medium brown clay
Declared Weeds	Broad-leaved pepper tree, lantana, groundsel bush
Erosion	Bank erosion, cattle watering point
Grazing Impacts	Heavy grazing
Fire History	>10
Fauna Habitat	Shallow water with emergent vegetation, salt affected, no logs/hollows/rocks
General Notes	Signs of salinity, salt scalds
Ground Truthed Regional Ecosystem	Regrowth vegetation (not RE)

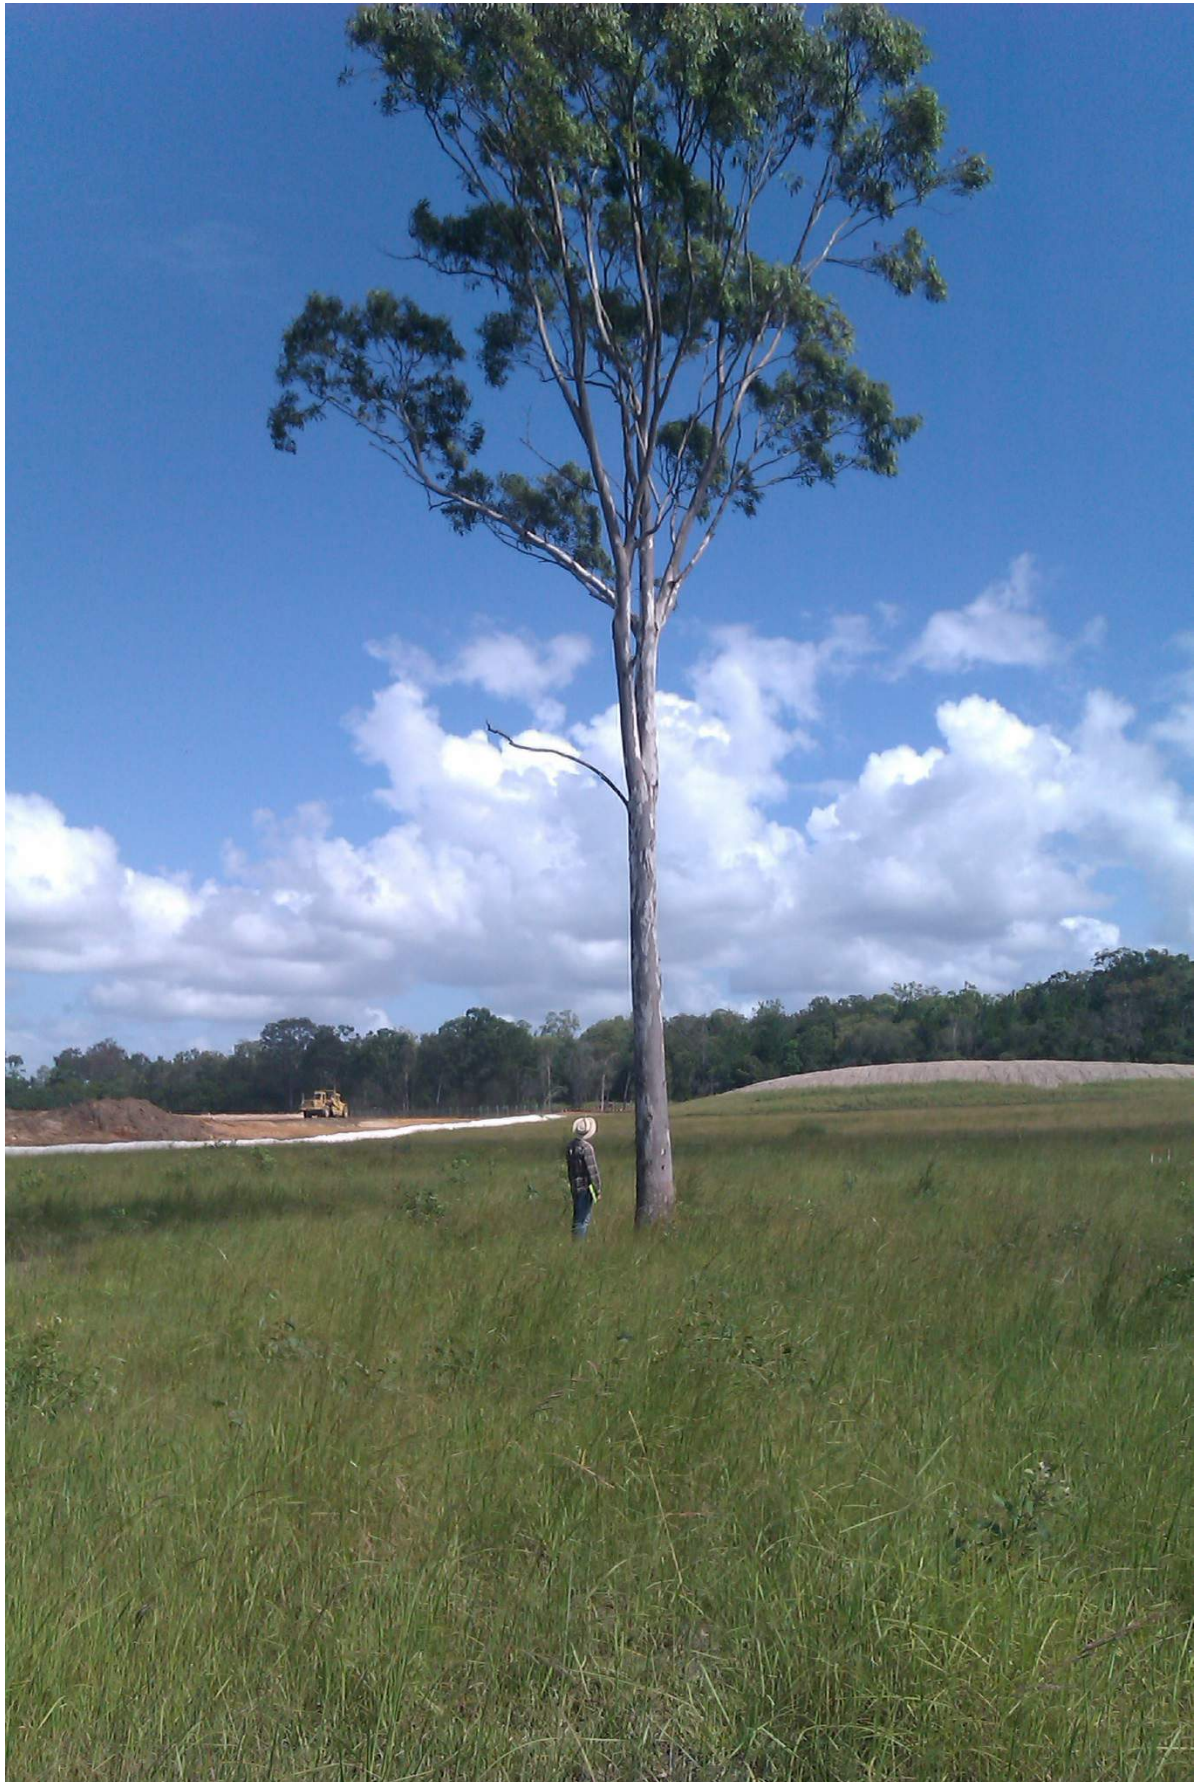
ASSESSMENT SITE 10

Assessment Site	10
Assessment Level	Quaternary
Survey Point	56J 499186 7000286
Aspect	flat
Slope (%)	flat
Geology	Flood plain
Soil	light brown clay
Declared Weeds	Possible rats tail grass
Erosion	nil
Grazing Impacts	moderate grazing
Fire History	>10
Fauna Habitat	Large paddock tree (Koala food tree), melon holes
General Notes	-
Ground Truthed Regional Ecosystem	Pasture (not RE)

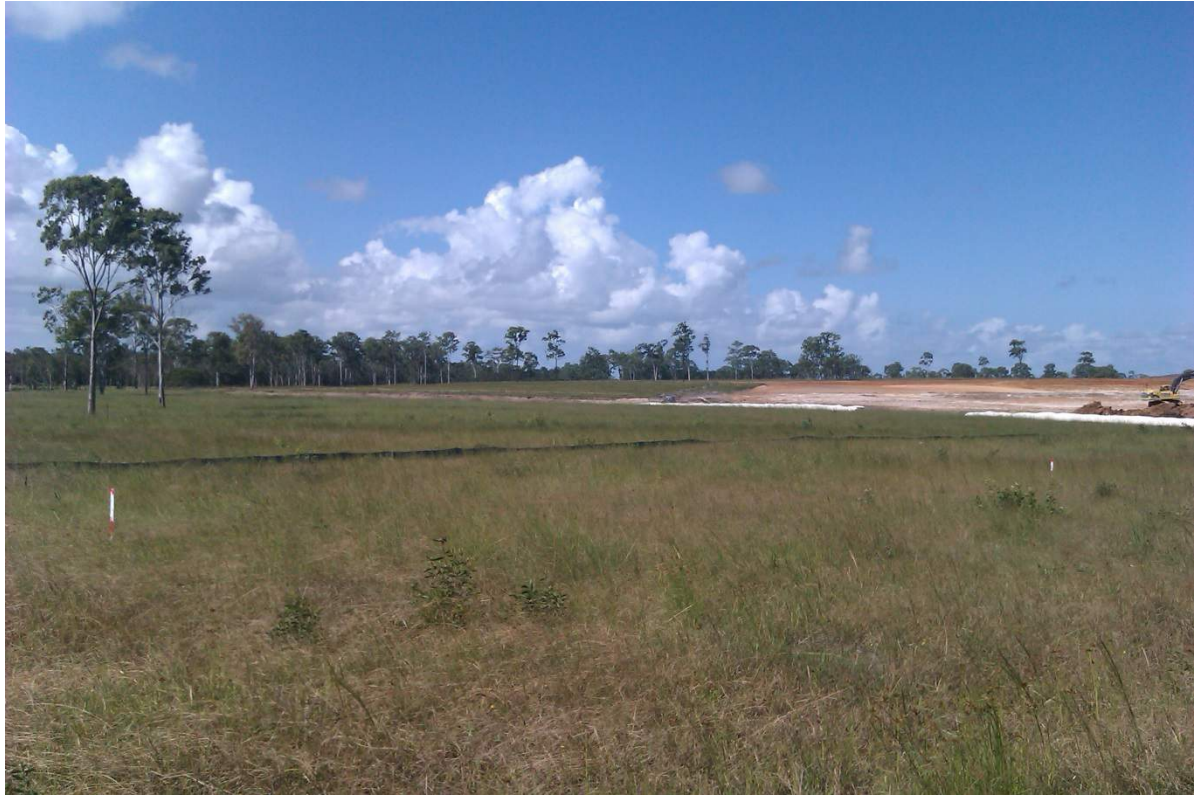
ASSESSMENT SITE 11

Assessment Site	11
Assessment Level	Quaternary
Survey Point	56J 499127 7000192
Aspect	North
Slope (%)	2%
Geology	Bottom of low hill
Soil	mid brown clay
Declared Weeds	-
Erosion	nil
Grazing Impacts	moderate grazing
Fire History	>10
Fauna Habitat	Melon holes
General Notes	Deep sewer construction underway
Ground Truthed Regional Ecosystem	Pasture (not RE)

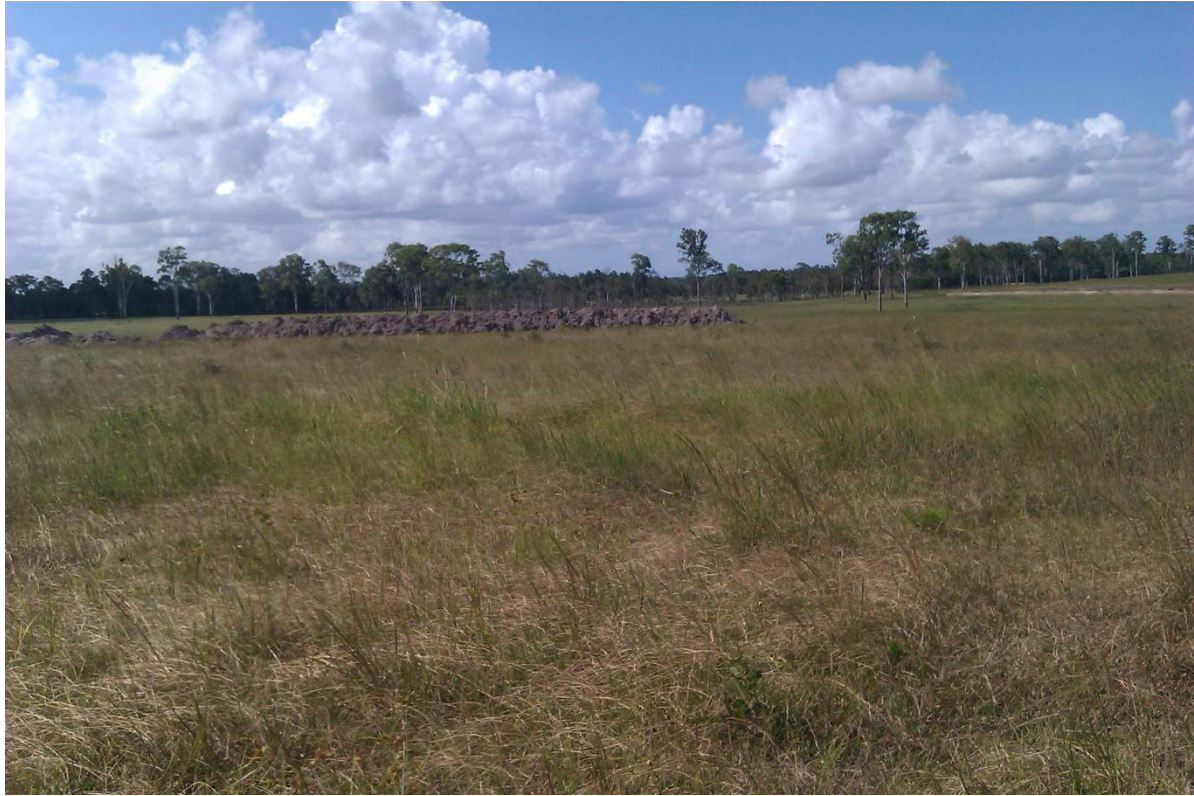
ASSESSMENT SITE 12

Assessment Site	12
Assessment Level	Quaternary
Survey Point	56J 499102 7000047
Aspect	North
Slope (%)	5%
Geology	Middle of low hill
Soil	mid brown sandy clay
Declared Weeds	nil
Erosion	Batters of soil dump have rill erosion
Grazing Impacts	occasional grazing
Fire History	>10
Fauna Habitat	South of the site is remnant woodland
General Notes	Deep sewer construction underway
Ground Truthed Regional Ecosystem	Pasture (not RE)

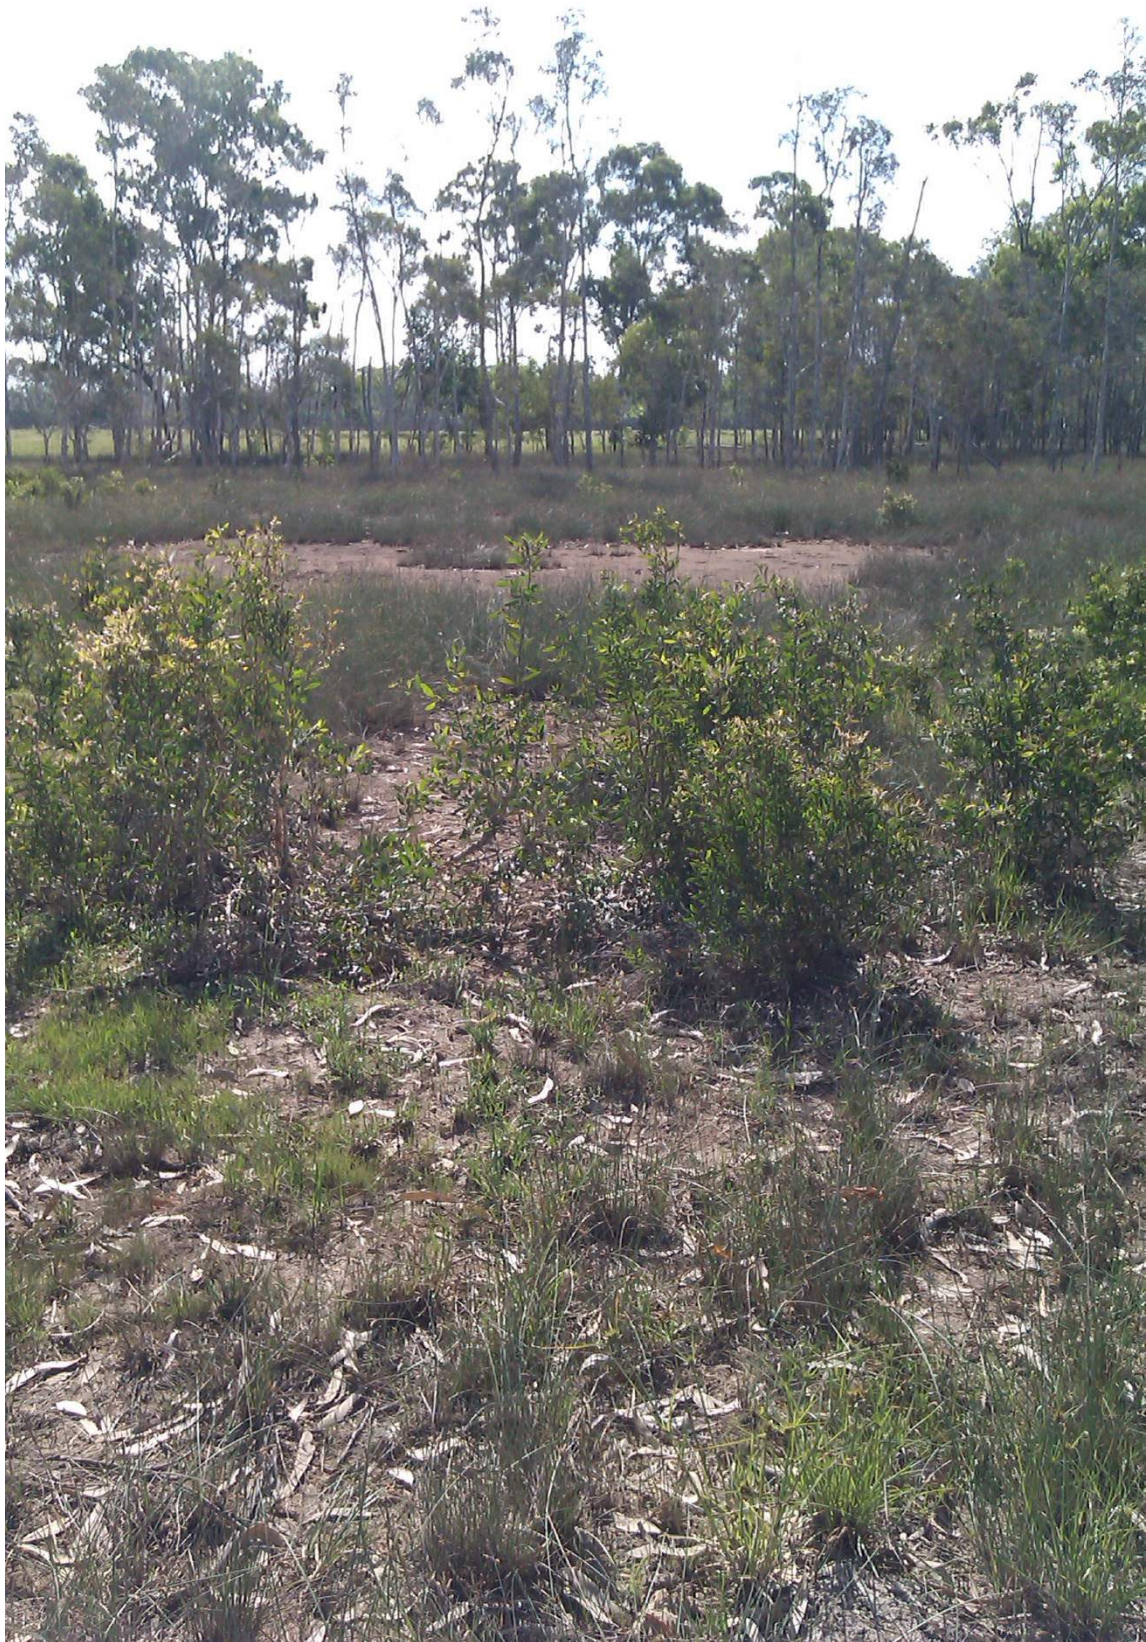
ASSESSMENT SITE 13

Assessment Site	13
Assessment Level	Quaternary
Survey Point	56J 499238 7000477
Aspect	flat
Slope (%)	flat
Geology	flood plain
Soil	Medium brown clay
Declared Weeds	Broad-leaf pepper tree
Erosion	Bank erosion, cattle watering point
Grazing Impacts	Heavy grazing
Fire History	>10
Fauna Habitat	Shallow water with emergent vegetation and tidal influence, small marine clay pan, 2 Koala food trees, fallen log
General Notes	Signs of salinity, salt scalds
Ground Truthed Regional Ecosystem	Regrowth vegetation (not RE)

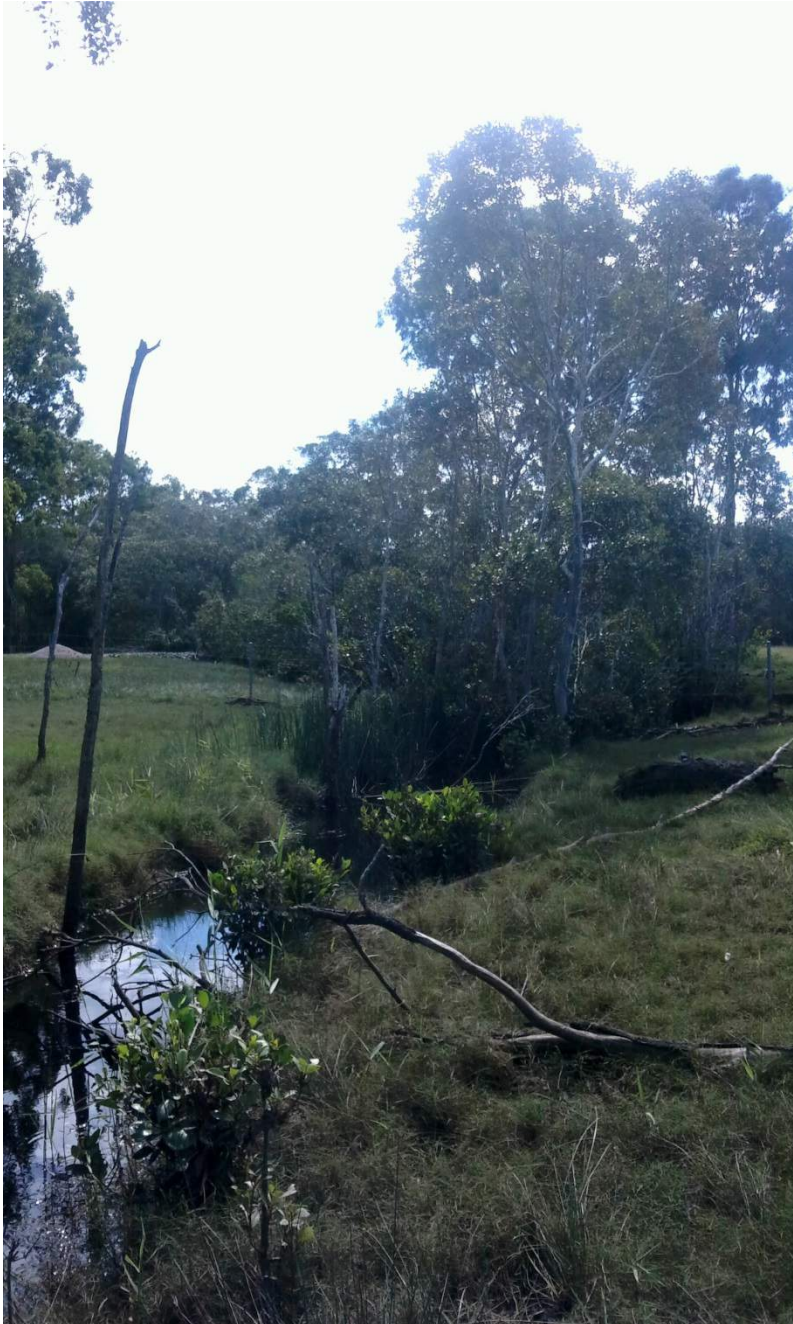
ASSESSMENT SITE 15

Assessment site	15
Vegetation Assessment level	Veg confirmation
Survey point (zone 56)	E499485, N7000605
Hydrology indicators	creek line
Fauna habitat	0
General notes	cattle disturbance
Vegetation	Mangroves
Level of disturbance	Significant
