LAND BASED ENVIRONMENTAL MANAGEMENT PLAN - SUB-PLAN 03

North East Business Park
Residential West Area - Phase 2

A Report Prepared for
North East Business Park Pty Ltd

AS AMENDED
JULY 2015

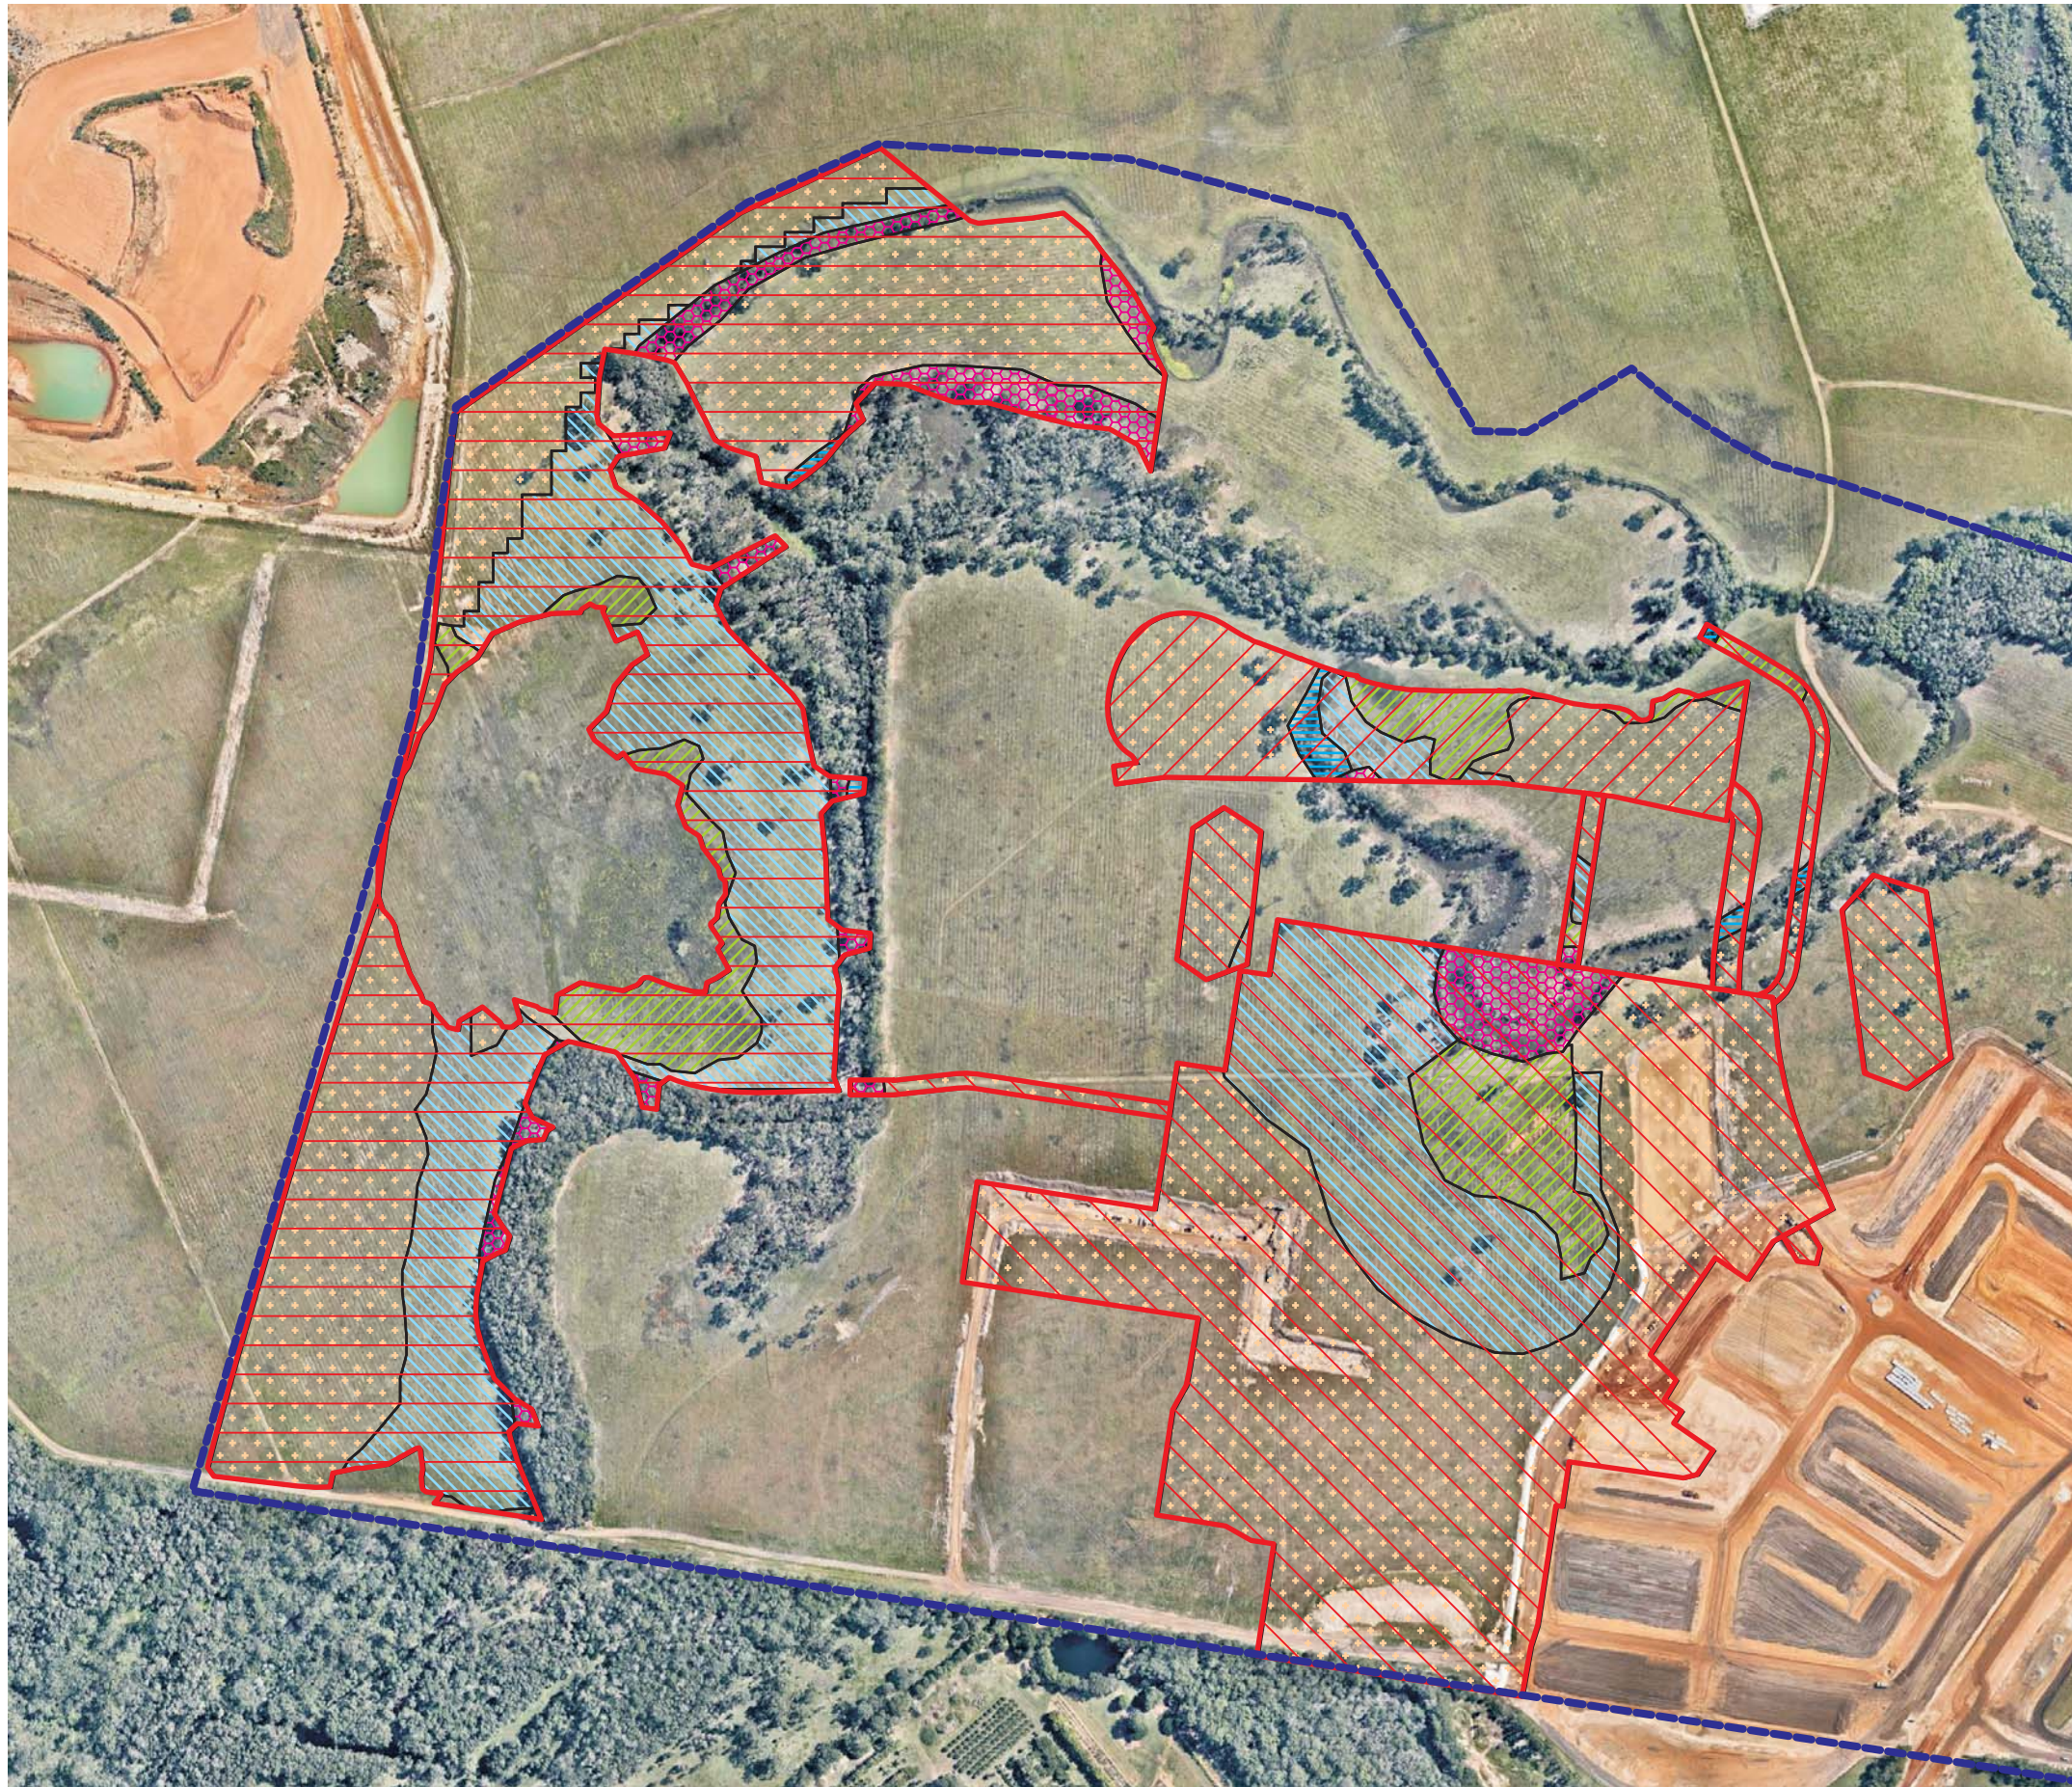
APPENDIX B
FIGURE 1
 PREPARED: BW
 DATE: 08 June 2015
 FILE: Q15003_Veg Clearance.cdr

TITLE
VEGETATION
CLEARANCE
PLAN

Vegetation to be Impacted by Phase 2 Works

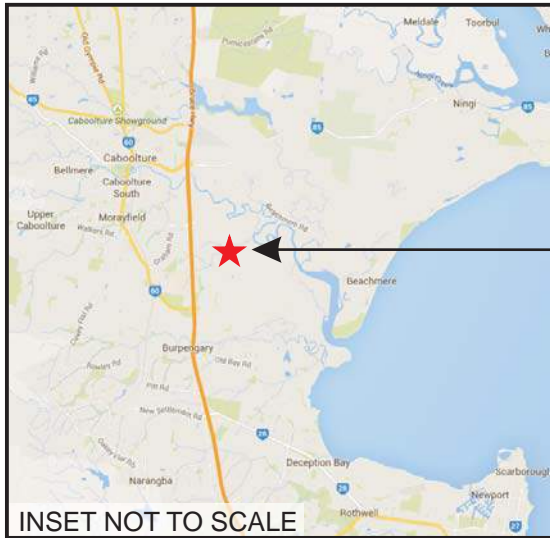
FIGURE 1

The RWA is located at Nolan Drive Morayfield and is formally described as Lots 2 and 3 on SP266287 (**FIGURE 1**). The RWA is approximately 174ha in area. The Open Space Precinct is approximately 87ha in area. The locations and extents of the NEBP site, the RWA and the Open Space Precinct are shown in **FIGURE 2**.
